2022 Ford E-Transit

Weak Key Fob – Failure to Recognize

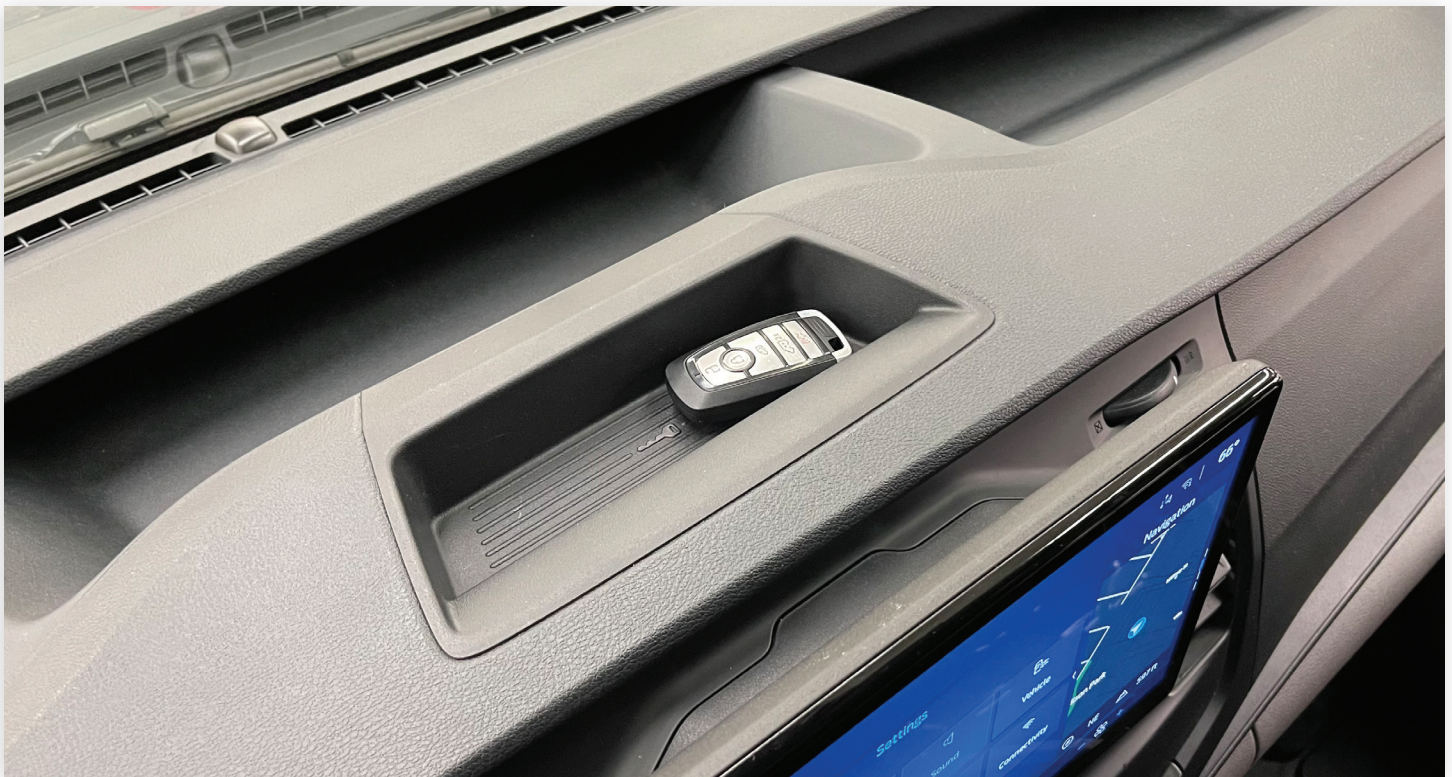
When E-Transit proximity Key Fob Batteries become weak the vehicle may have difficulty acknowledging its presence and not start.

The designated area in the E-Transit is in the tray on top of the dashboard.

Placing the Key Fob in the designated area will aid in starting the vehicle.

Immediately replace the weak Key Fob Battery
