2022 Ford F-150 Lightning EV

Weak Key Fob – Failure to Recognize

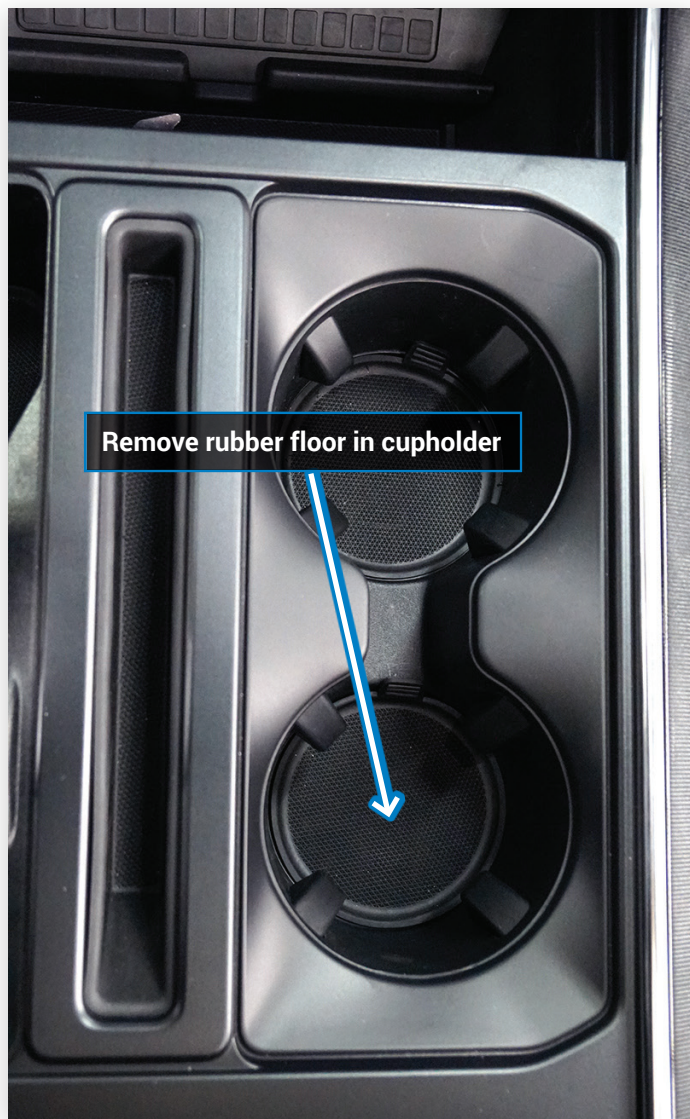
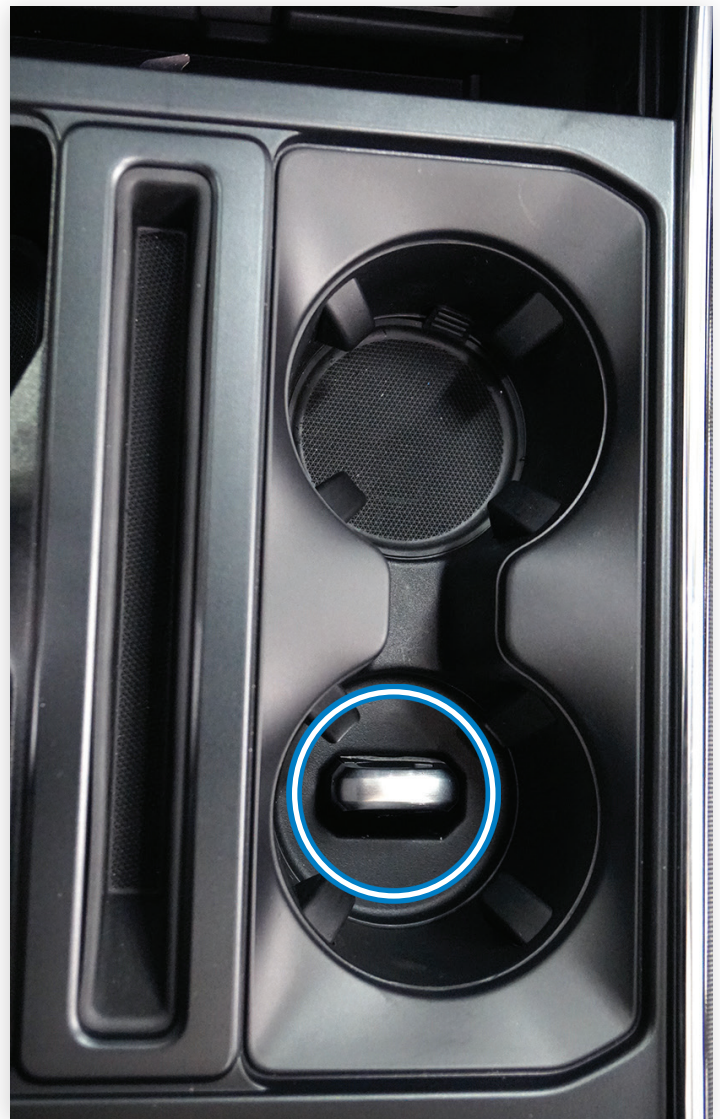
When F-150 Lightning proximity key fob batteries become weak, the vehicle may have difficulty acknowledging its presence and not start.

The designated area in the F-150 Lightning is in the rear cup holder in the center console.

Placing key fob in the designated area will aid in starting the vehicle.

Immediately replace the weak key fob battery.
